DSL-IP LEARNING EVENT

GOOD PRACTICES IN FIRE MANAGEMENT – 25TH APRIL 2024

**Use of Sediment Retention Fibre Rolls (SRFR) and Erosion Blankets
to stabilise slopes after fire – Example from South Africa**

Dirk Pretorius - SMC Synergy

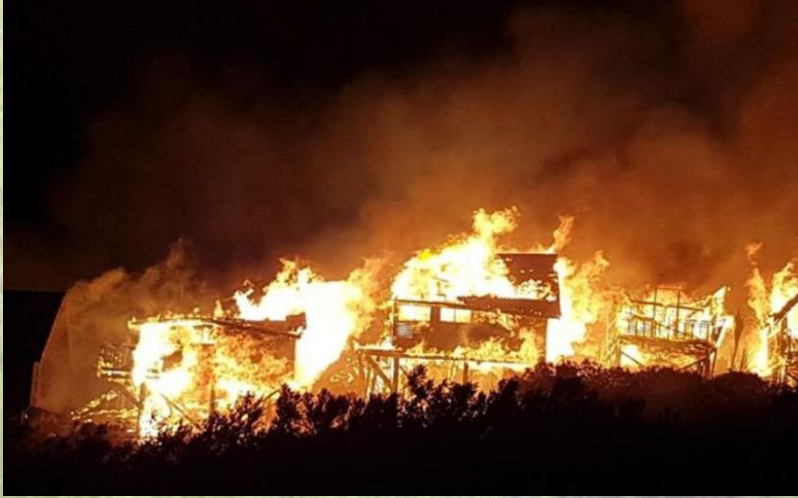
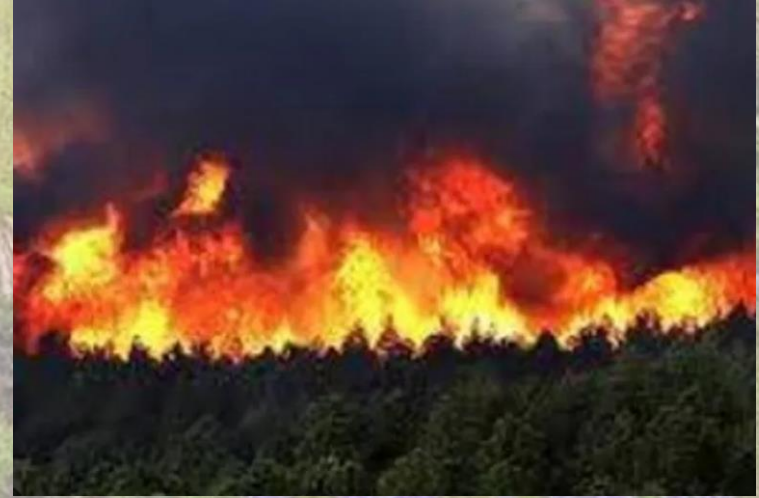
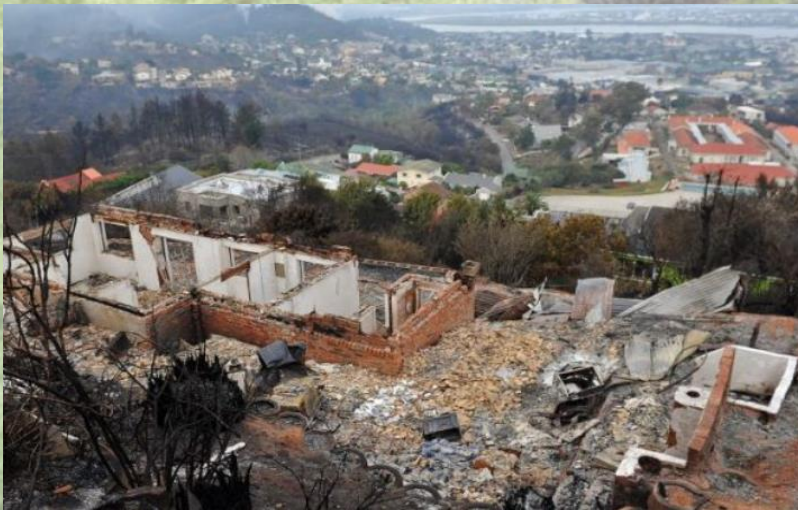
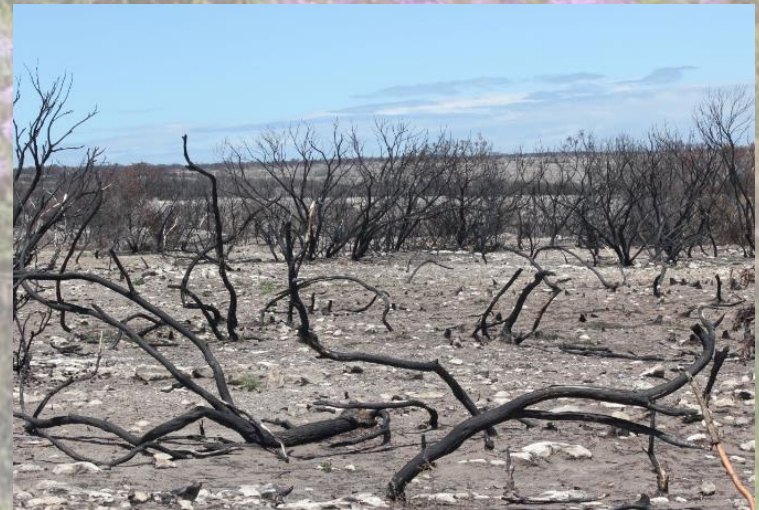
Background (damage caused by the wild fires)

- ❑ The area receives summer and winter rainfall with an annual average of around 650 to 700 mm.
- ❑ The Knysna fires were the worst wildfire disaster in South African history (more than 21 000 ha were affected – destroying more than 800 buildings, 5000 ha of forest plantations and claiming the lives of seven people).
- ❑ Investigations reported that its severity was caused by a cocktail of factors, including drought, low atmospheric humidity, strong warm Bergwind conditions and abundant biomass.
- ❑ After the fires, the lack of vegetation cover on steep sandy slopes in the affected areas posed an immediate danger of erosion and landslides to downstream catchments, ravines and man-made infrastructure.

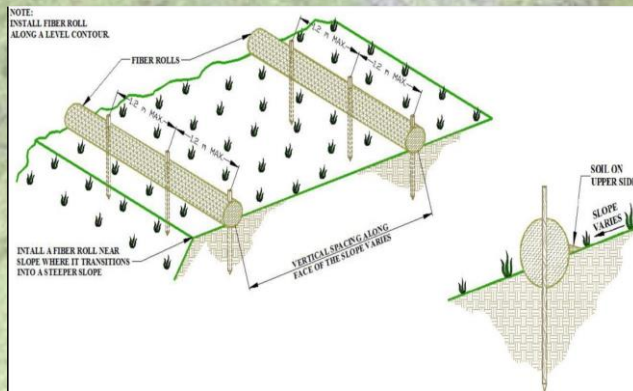
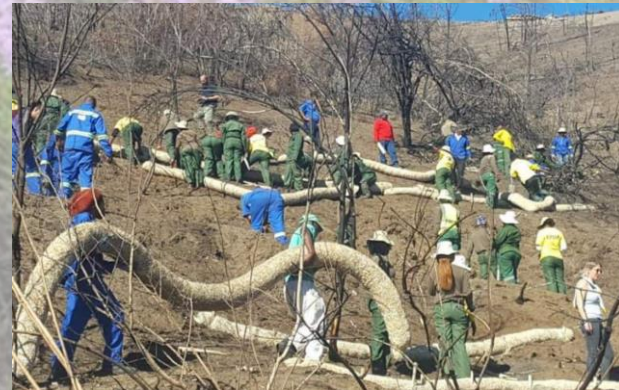
▣ Installation of the SRFR

- Prepare the area to be restored.
- Determine the spacing of the rolls as a function of soil type and slope.
- Installation of erosion rolls (6 m long) and blankets (2.5m x 50 m) – blankets must overlap.
- Use wooden stakes to secure the rolls and blankets – rolls (50cm) – 1.2 meter apart, blankets (30cm) – 1meter apart.

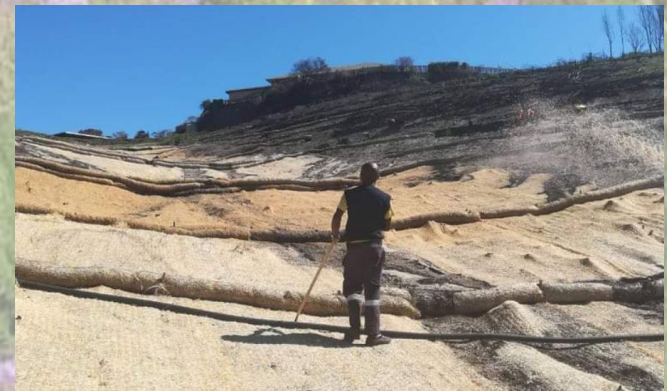
- ▣ **Installation of the erosion blankets**
 - Ensure the site is properly prepared before installing any blankets. The site should be fine graded to a smooth profile and relatively free from all weeds, clods, stones, roots, sticks, rivulets, gullies, crusting and caking. Voids are filled and the slope should be compacted properly.
 - An anchor trench 20 cm deep by 20 cm wide is dug at the top of the slope. The blankets will be anchored in this trench with stakes.
 - Starting at the crest of the slope, the blankets are rolled down the slope in a controlled manner.
 - Proceed with seeding (hydroseeding) of the area to be restored.

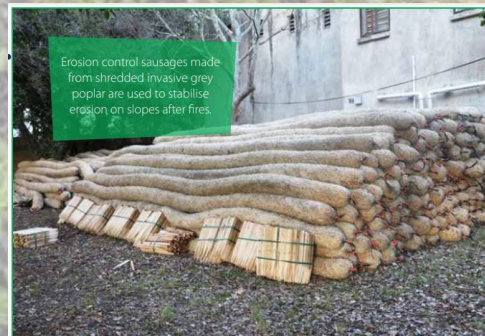
Erosion control sausages made from shredded invasive grey poplar are used to stabilise erosion on slopes after fires.

Sausages and blankets are used by disaster management after fires and floods to stabilise slopes and prevent mud slides.

Erosion control sausages proved to be vital in stabilising steep slopes around Knysna after devastating fires burnt away thousands of hectares of forest in the southern Cape in June 2017.

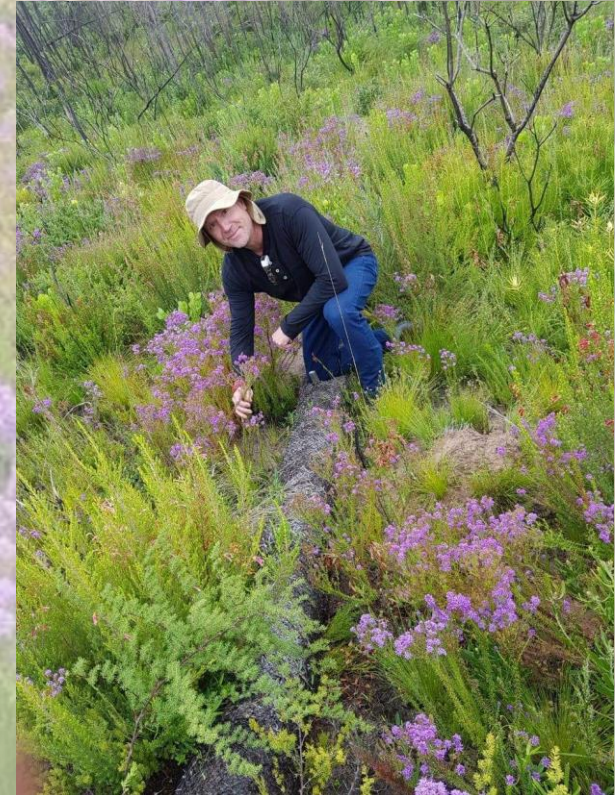
- ▣ It is estimated that 53 km of wood fibre rolls (or "sausages") and 54 000 m² of erosion blankets have been installed in the post-fire erosion mitigation projects - reducing the risk of land slides and flooding.
- ▣ Vegetation cover improved with the introduction of hydroseeding and retention of topsoil containing indigenous seeds.
- ▣ The introduction of sediment trapping structures as well as improved vegetation cover resulted in less downstream siltation.
- ▣ Restoration resulted in job creation for local communities.
- ▣ Improved ecotourism - land restored to natural state - hiking and cycling.
- ▣ Maintenance of the applied technology included the removal of alien species.
